NASA Contractor Report 4617

# Results of the Examination of LDEF Polyurethane Thermal Control Coatings

*Johnny L. Golden*  
*Boeing Defense & Space Group • Seattle, Washington*

July 1994

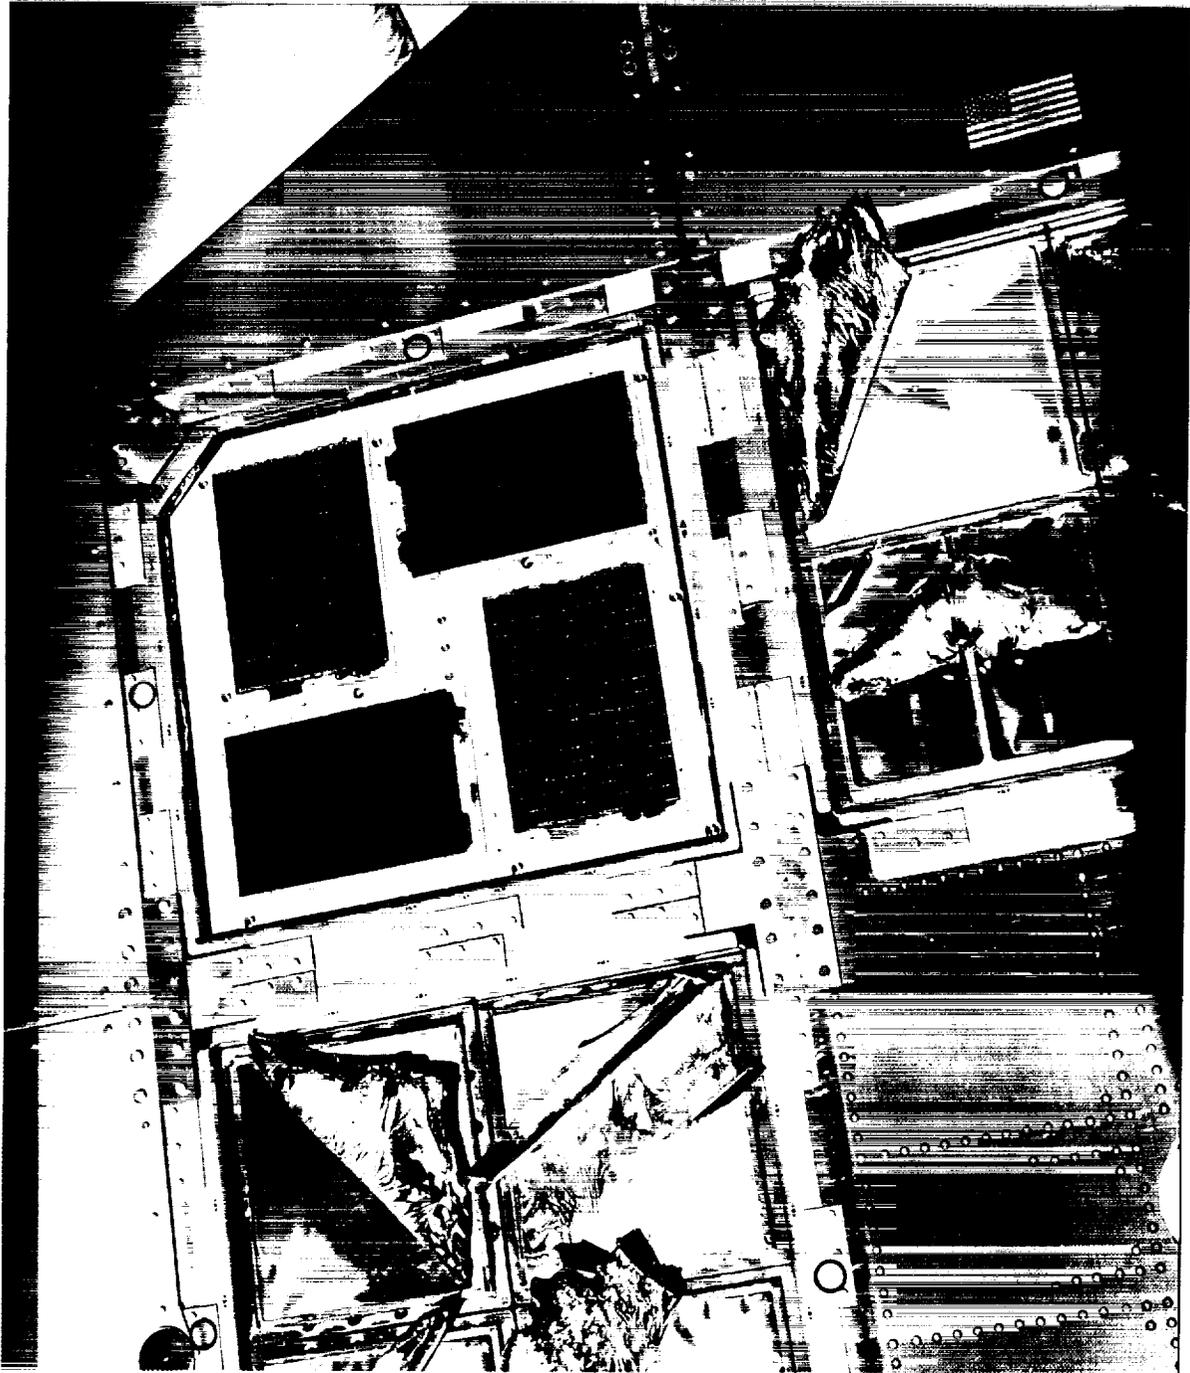
Figure C6. On-Orbit view of paint disks on the space end of LDEF. NASA Johnson Space Center Photo No. S32-75-036. U. S. flag is above tray H12. Color version of figure 6, page 17.

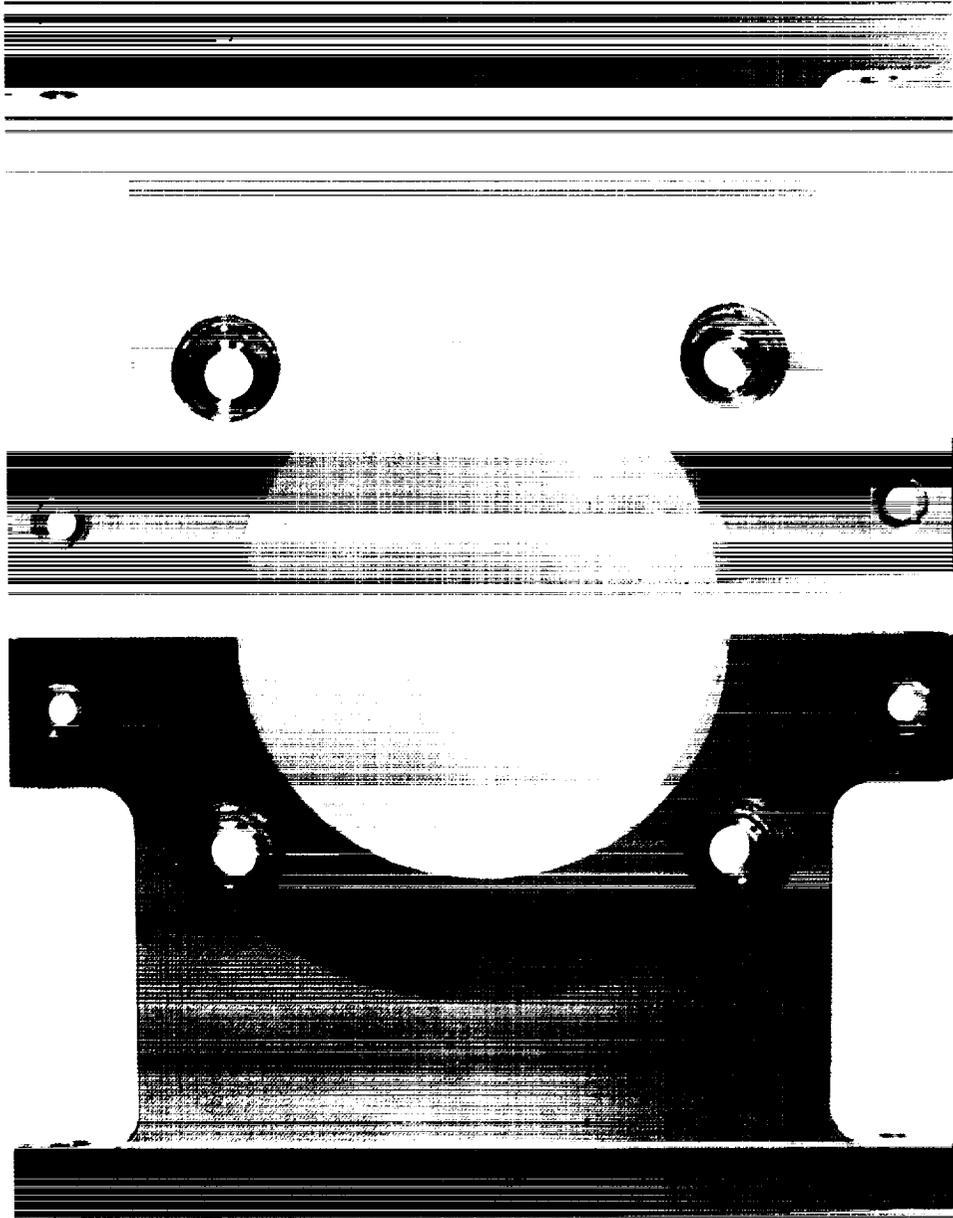
The A971 yellow polyurethane coating specimens were parts from trunnion scuff plate assemblies, located between trays C3 and D3 and between trays C9 and D9 on the LDEF center ring frame. The trunnion scuff plates are part of the interface between LDEF and the Space Shuttle payload bay. The A971 coating specimens are shown in figure 11. The lower specimen was exposed to  $1.3 \times 10^{17}$  oxygen atoms/ $\text{cm}^2$  and 11,100 ESH of UV radiation. The upper specimen, lighter in color, was exposed to  $9.0 \times 10^{21}$  oxygen atoms/ $\text{cm}^2$  and 11,200 ESH of UV radiation (ref. 1 and 2).

Figure C11. Chemglaze A971 yellow paint on components of the leading (above) and trailing edge scuff plates. Color version of figure 11, page 22.
